# Intel® Xeon™ MP Processor

## Specification Update

*October 2003*

Document Number: 290741-021

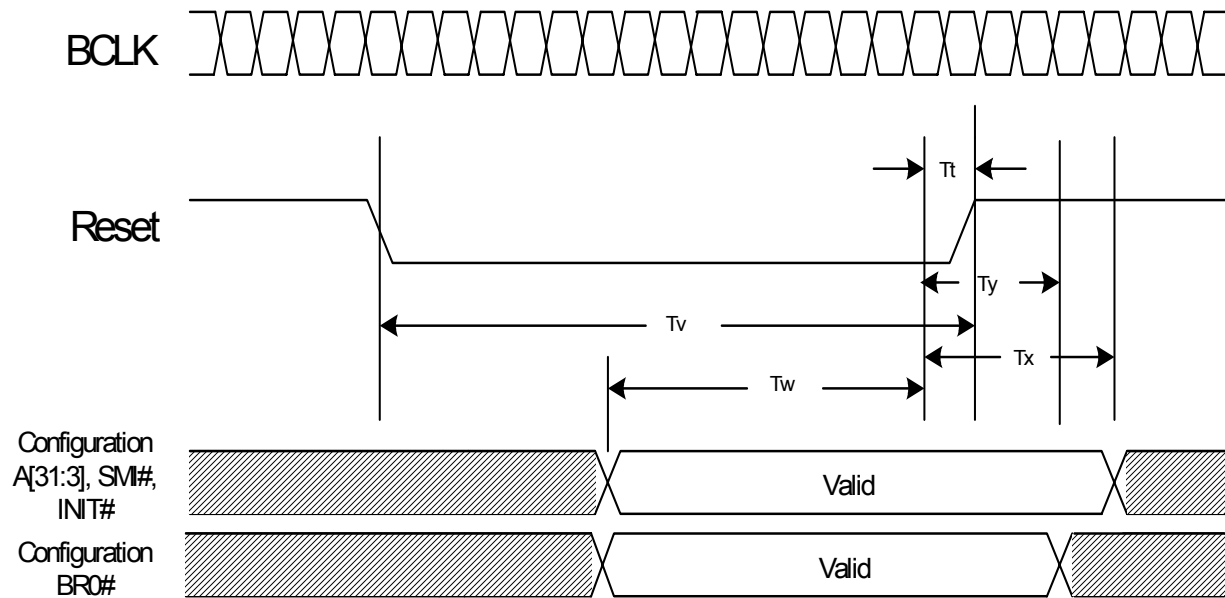
System Bus Reset and Configuration Timings

The BR0# maximum hold time has changed to 2 BCLKs. This change will be shown in the "System Bus AC Specifications (Reset Conditions)" table and "System Bus Reset and Configuration Timings" figure of the above mentioned datasheets. This change will be incorporated in the next revision of the above datasheets.
